ERDC/CHL TR-03-16

## **Assessment of Changes in Channel Morphology and Bed Elevation in Mad River, California, 1971-2000**

Kevin Knuuti and Dinah McComas

September 2003

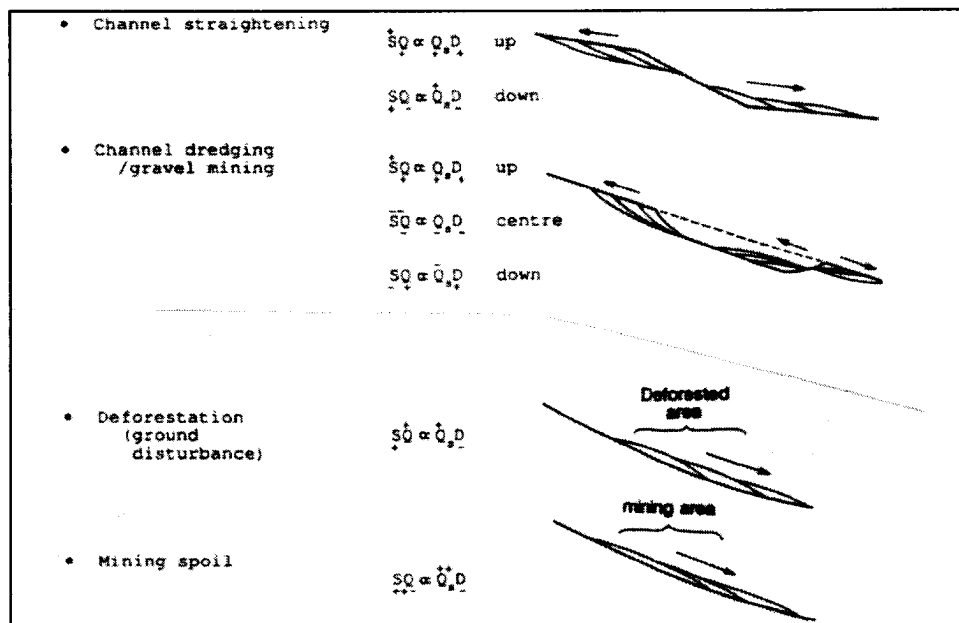
Figure 6. Graphic depiction of channel response to external actions (Hey 1986)

where  $Q_s$  is the bed-material load,  $D$  is the sediment size,  $Q_w$  is the water discharge, and  $S$  is the channel slope. Using this relationship, the effects on a stable river of change in one variable can be predicted (see Figure 6 and Table 3). The effects can differ for the areas immediately near, upstream, and downstream from the change.

Typically, however, a change in the bed-material load will have an effect that migrates downstream while a change in the channel bed level or slope will have an effect that migrates upstream. With these relationships in mind, available data and information on the Mad River were examined to determine what effects gravel mining might have on the morphology of the river. For a case of negative sediment storage in the study area (gravel extraction greater than area storage), Table 3 indicates that the river should respond and exhibit a degraded bed upstream and downstream of the mined area with probable evidence of headcutting in area tributaries.

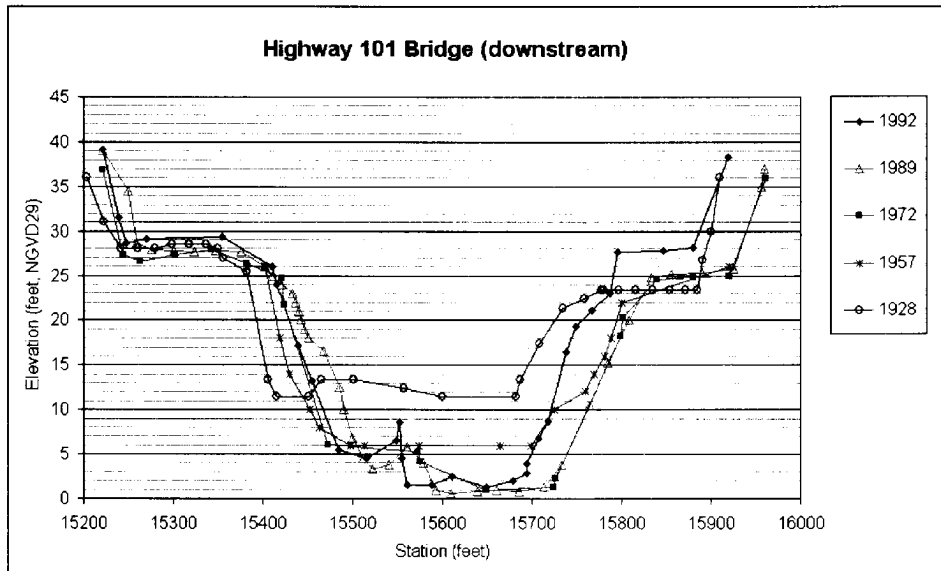
Figure 8. CalTrans surveyed cross section, downstream side of Highway 101 bridge

For the Highway 101 bridge, CalTrans measured upstream and downstream channel cross sections in 1928, 1929, 1957, 1972, 1989, and 1992. The 1928 (downstream) and 1929 (upstream) channel cross sections are based on data that were collected during or immediately after construction and represent the as-built condition.

Accounting for the uncertainty associated with the methods CalTrans used in measuring the Highway 101 bridge cross sections, the cross sections still indicate approximately 6 ft of bed degradation between 1957 and 1992. They also indicate approximately 1 ft of degradation between 1972 and 1992.

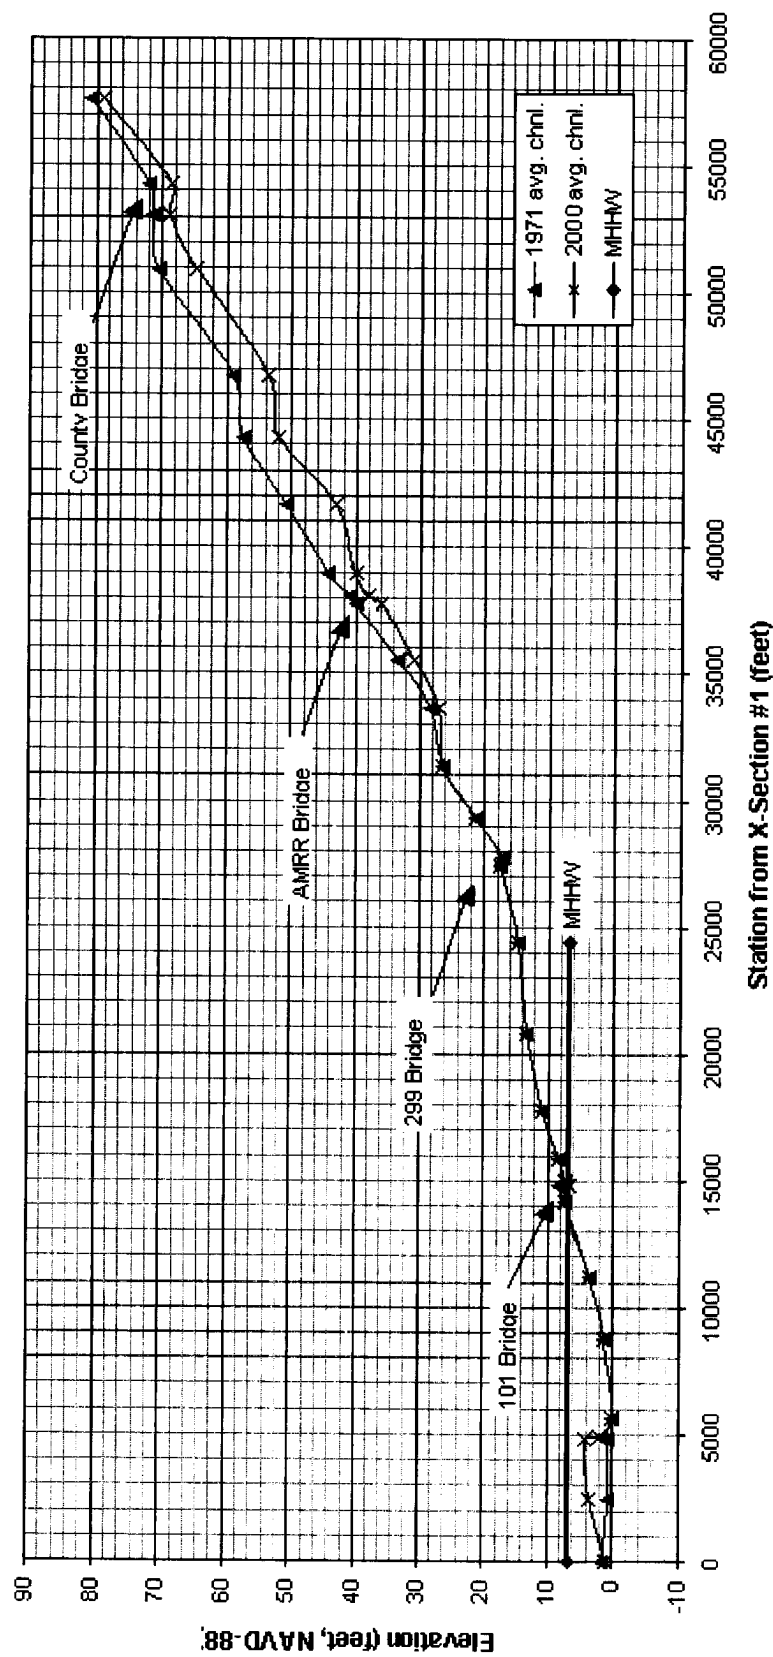
# **Mad River Longitudinal Profile** **1971-2000**

Figure 13. Longitudinal profile showing average (across cross sections) bed elevation changes from 1971 to 2000

The 1971 and 2000 Corps of Engineers' cross sections were initially used to evaluate changes in river morphology and sediment transport in two ways. Initially, cross sections at specific locations from 1971 and 2000 were compared to each other to determine whether or not the river had widened, deepened, shallowed, or shifted. Average (across each cross section) changes in bed elevation were plotted along a longitudinal profile of the river and examined for vertical change trends (see Figure 13).

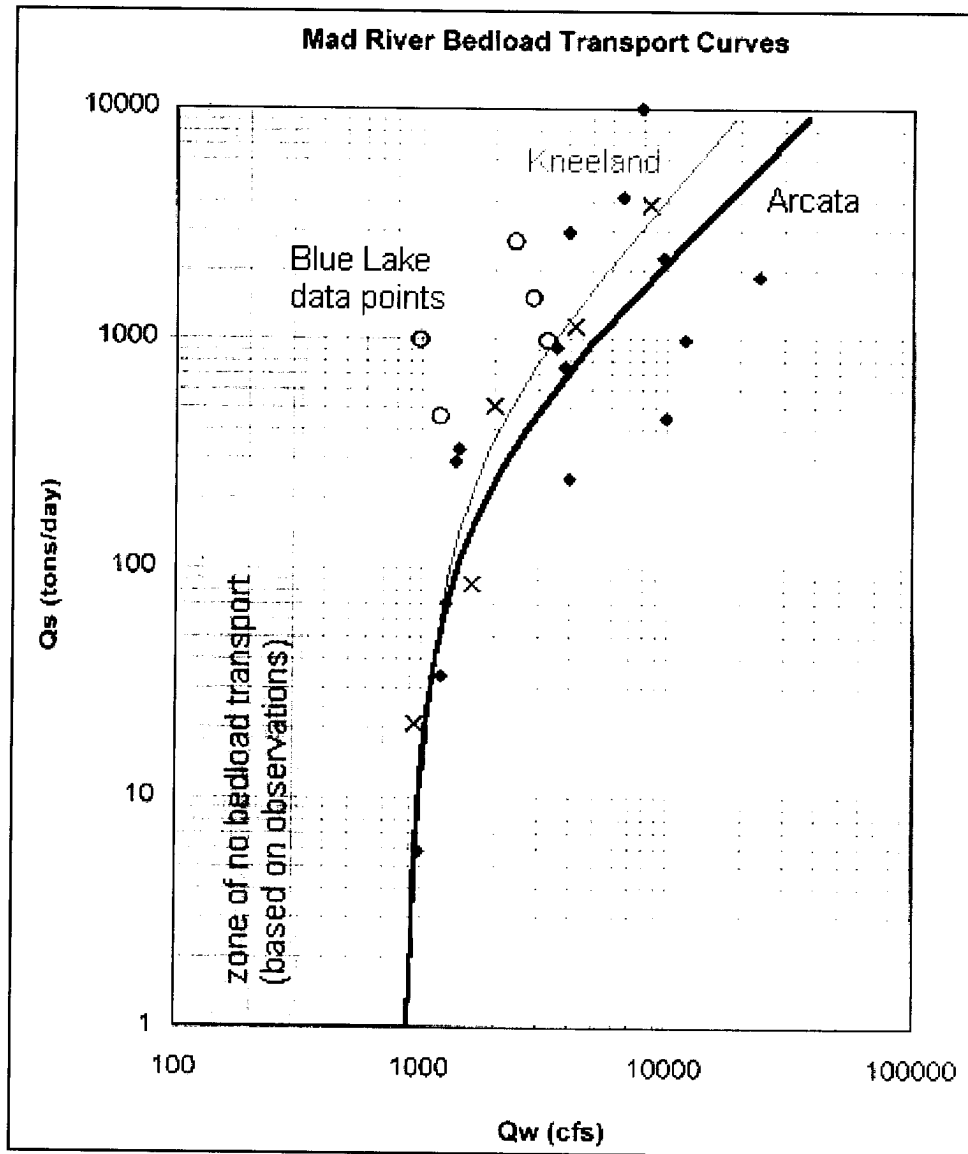
Figure 17. Bed-load data and sediment rating curves

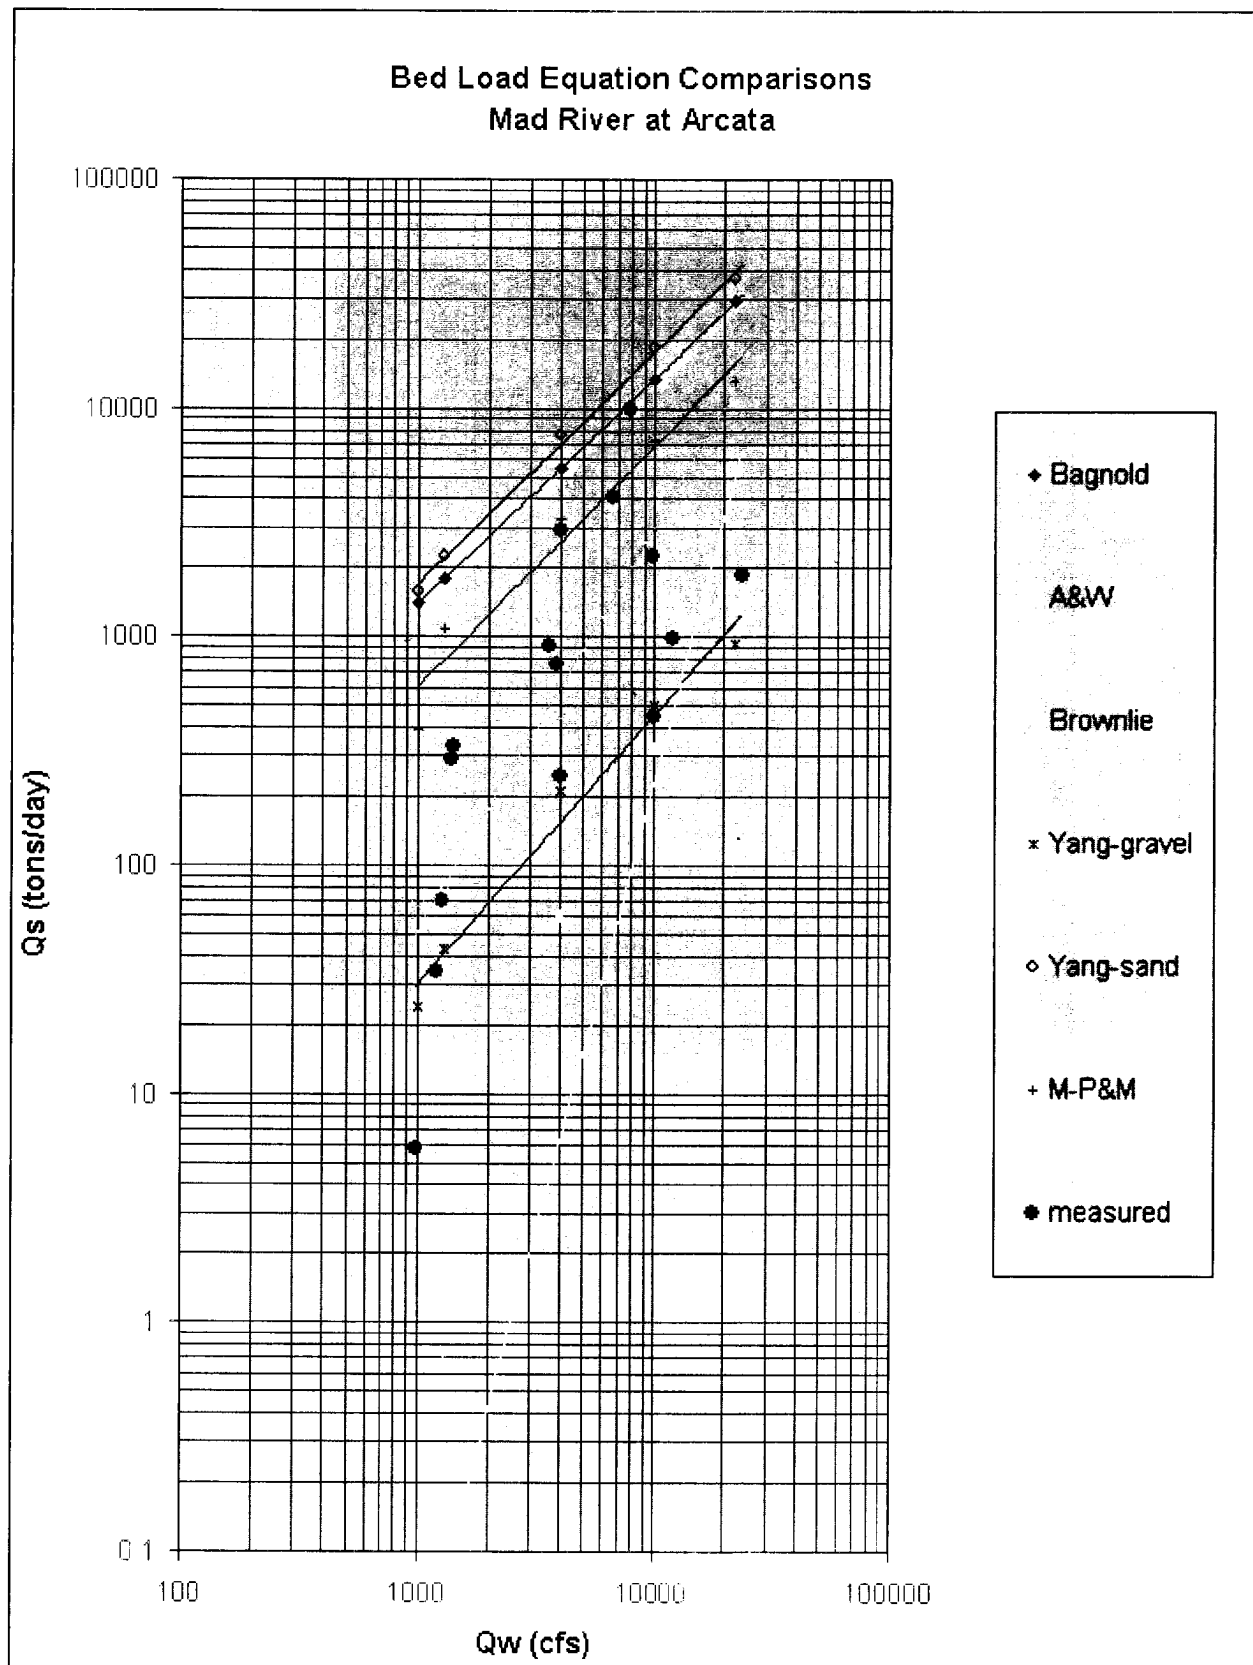
Figure 18. Bed-load equations and data for Arcata gauge

In attempting to determine why an equation developed for sand transport conditions is such a good fit for a gravel-bed river, one must examine the grain-size distributions for the bed-load data and bed-material data on the Mad River. Figure E-1 shows the bed-load samples collected at the Arcata gauge to be primarily sand, while Figures E-2 and E-3 show the bed-load samples collected at the Blue Lake and Kneeland gauges to be primarily fine gravel. Figure F-1 shows the bed-material samples collected at the Arcata gauge to be primarily gravel. A possible explanation for this could be that the Kneeland and Blue Lake locations have the capacity to transport gravels, but the Arcata location does not. This is not the case, however, as an examination of the critical shear stress necessary to move various sized sediments at the three locations indicates that the Arcata location has the capacity to move much coarser sediments than were collected in bed-load samples under various flow conditions (see Figures 21 and E-1). The absence of coarser material in the bed-load samples collected at Arcata could be due to a decrease in the amount of coarse material upstream, caused by gravel mining, by the natural fining of sediments as they move downstream (not a likely cause in this situation), or by other conditions related to sampling methods or bed conditions at the time of sampling. Without the field notes of the USGS personnel who collected the samples, it is difficult (or impossible) to discern the precise cause of this situation. If one considers that the bed-load samples collected at Arcata might underrepresent the amount of gravel in the bed load, then the Meyer-Peter and Muller equation may be more appropriate for representing conditions on the Mad River (see Figures 18, 19, and 20).

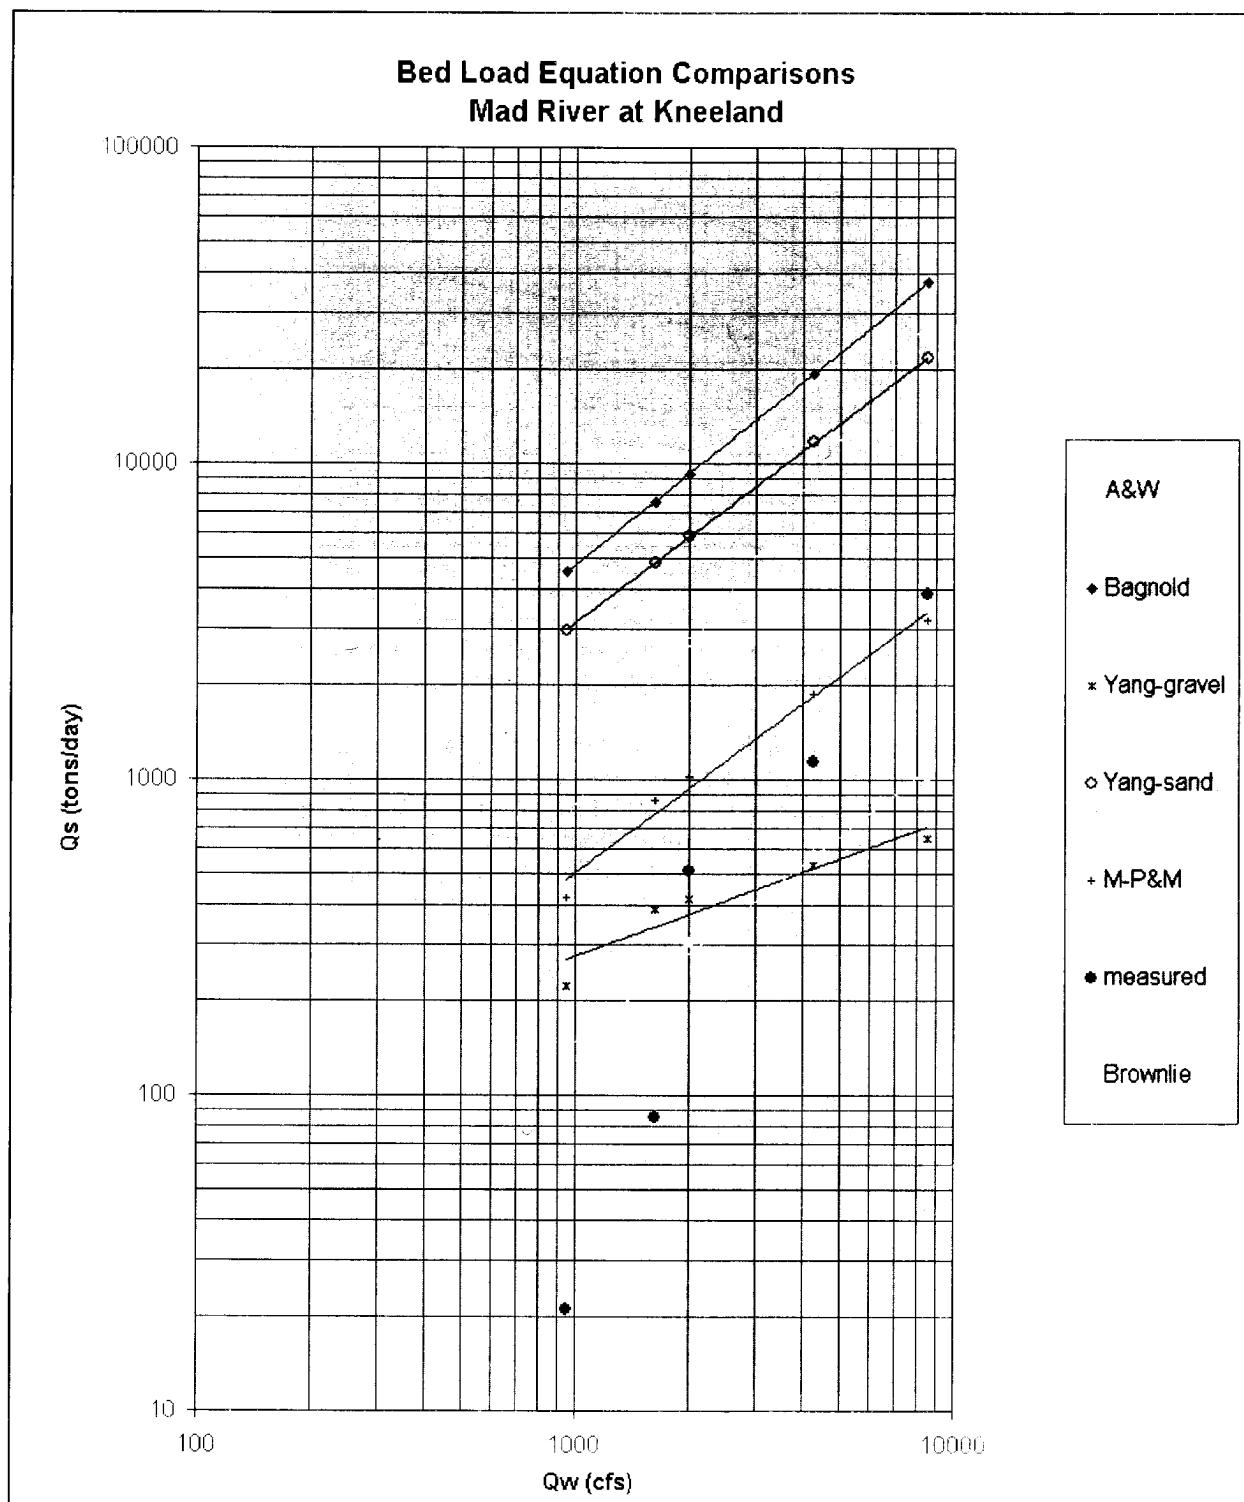
Figure 20. Bed-load equations and data for Kneeland gauge

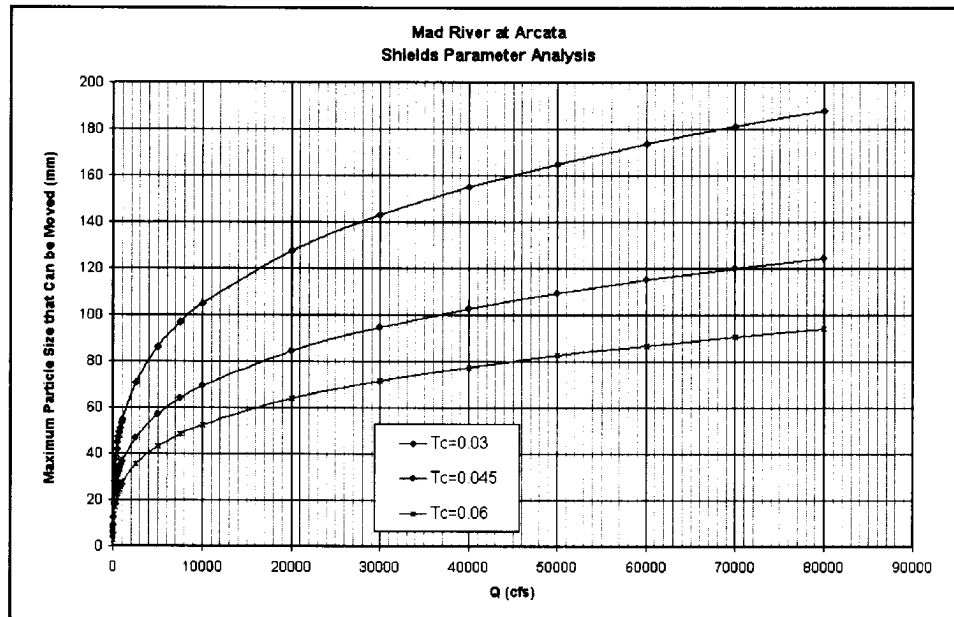
Figure 21. Shield's parameter analysis to estimate flows required to move various sized particles at Arcata gauge location

Though this could justify using the Meyer-Peter and Muller equation (which was developed using sand and gravel data) in lieu of Brownlie's equation, the justification is not adequate. Using the Meyer-Peter and Muller equation for sediment transport calculations would require assuming that the data collected were not representative of the actual conditions and would require speculating as to what those actual conditions should be. This would create additional uncertainty in the analysis.

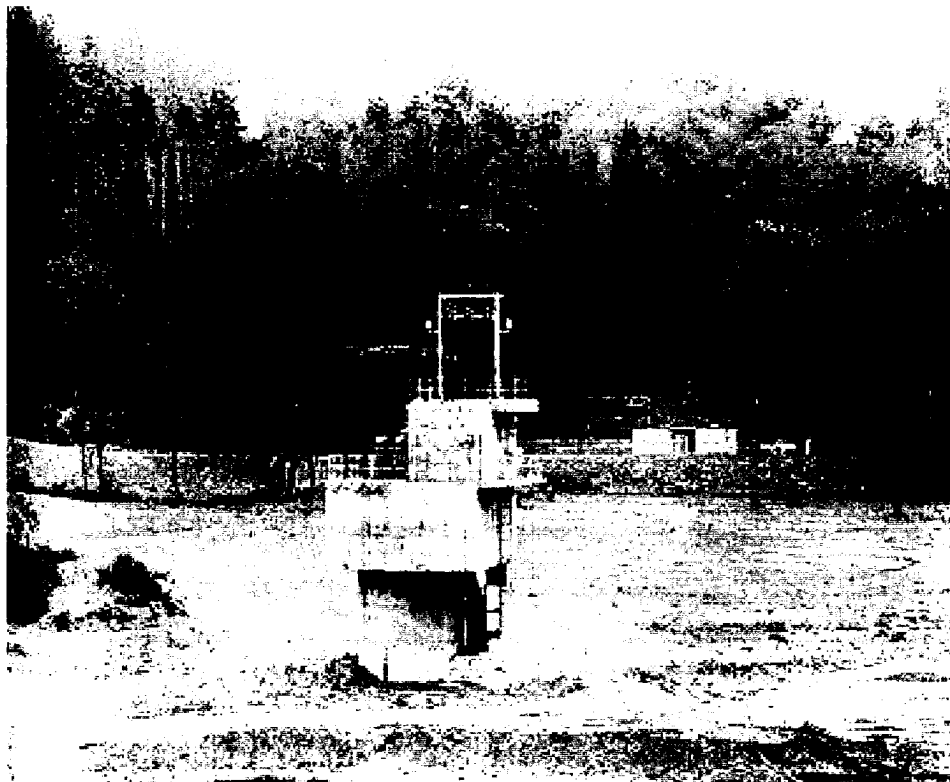
Figure D10. Raney collector near HBMWD operations building, circa 1965

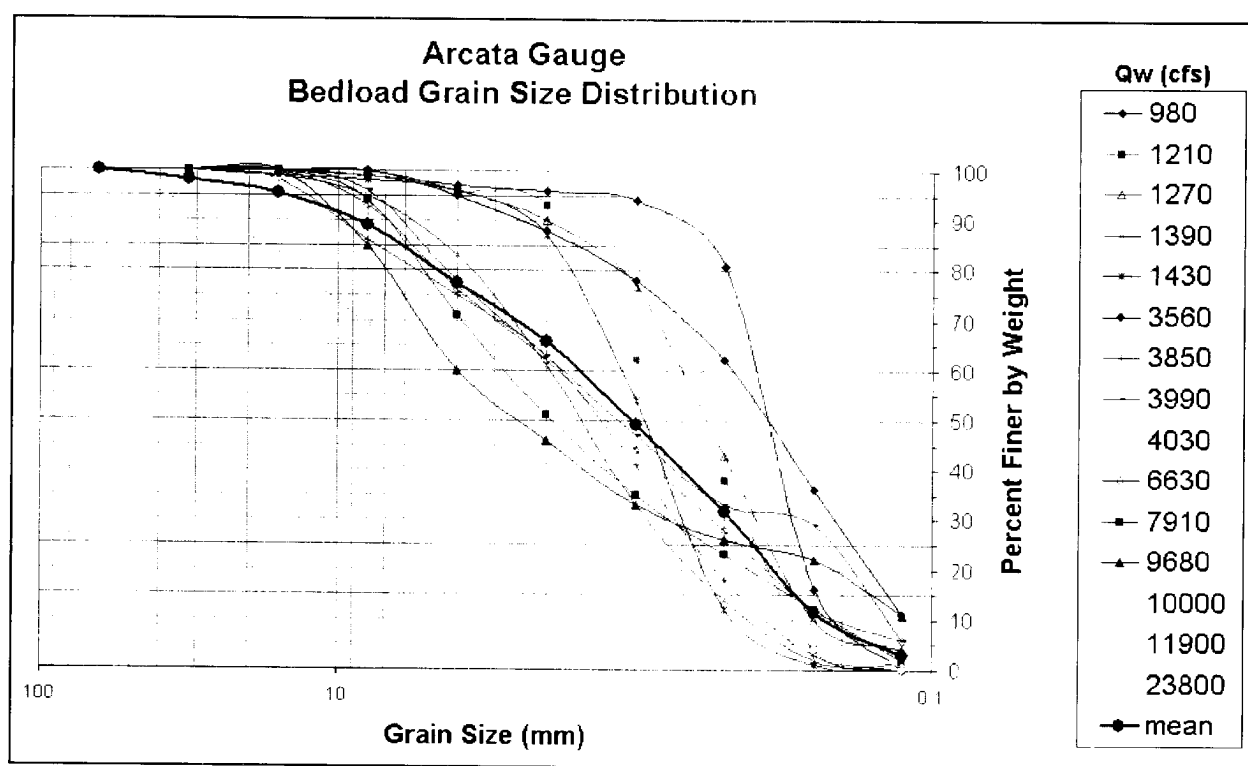
Figure E1. Arcata gauge bed-load grain-size distributions

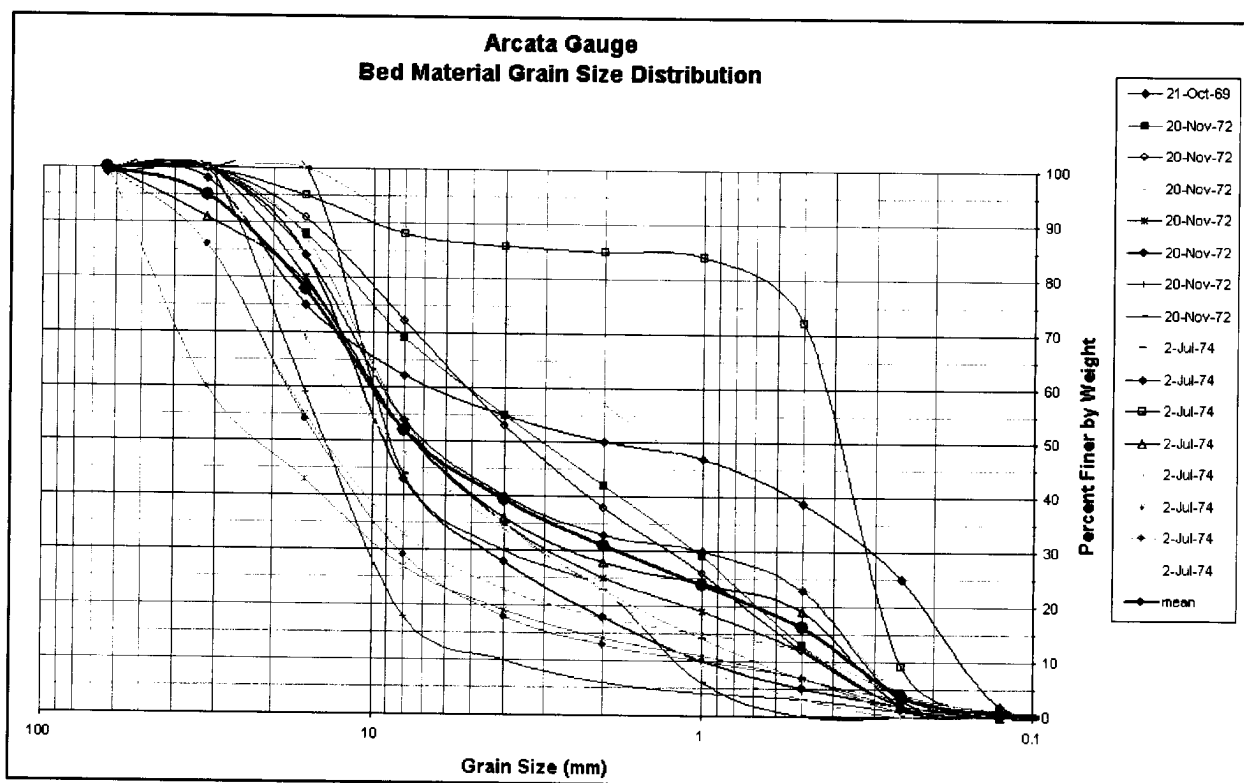
Figure F1. Arcata gauge bed-material grain-size distributions
